**Re: Pre-Demolition Asbestos & Universal Waste Survey
227 Johns Hill Road, Highland Heights, KY 4109
ATC Project Number 241BS00539**

REPRESENTATIVE PHOTOGRAPHS
PRE-DEMOLITION ASBESTOS & UNIVERSAL WASTE SURVEY
NORTHERN KENTUCKY UNIVERSITY – 227 JOHNS HILL ROAD, HIGHLAND HEIGHTS, KY

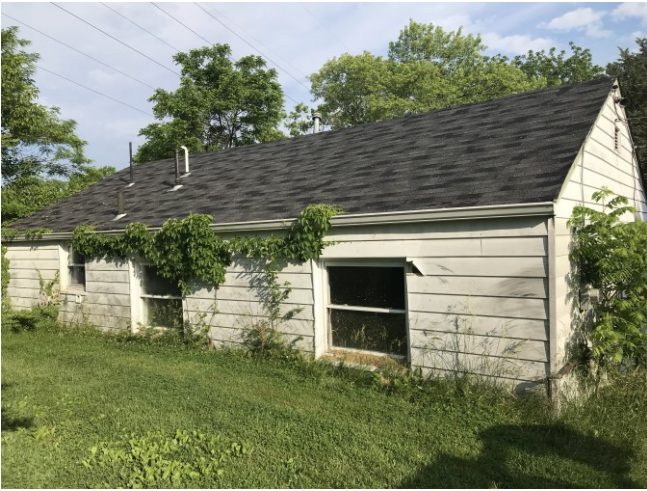
Location of Samples 227-1-1 (shingles/felt), 227-3-1 (fiberboard under siding) and 227-4-1 (window caulk)

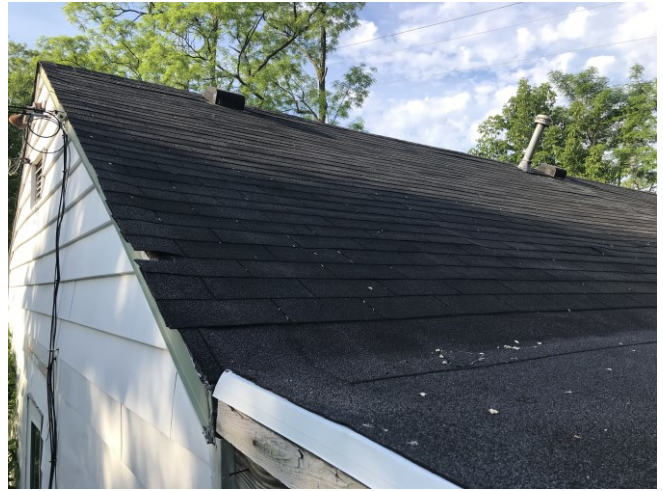
Location of Samples 227-1-2 (shingles/felt) and 227-2-1/2 (rolled roofing)

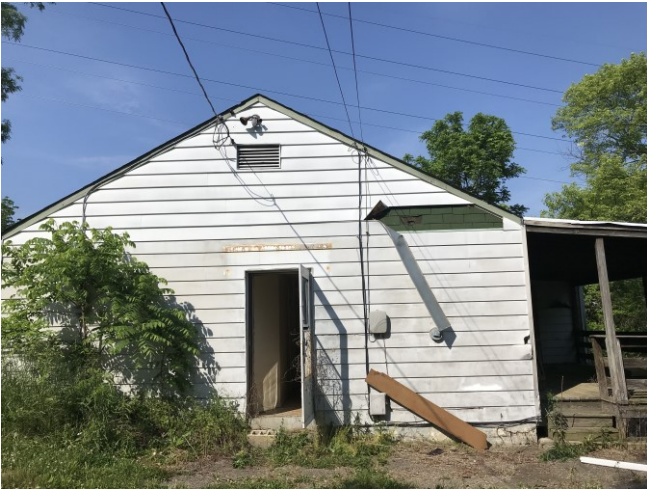
Location of Samples 227-15-1/2 (shingles under siding) and 227-16-1/2 (fiberboard under shingles)

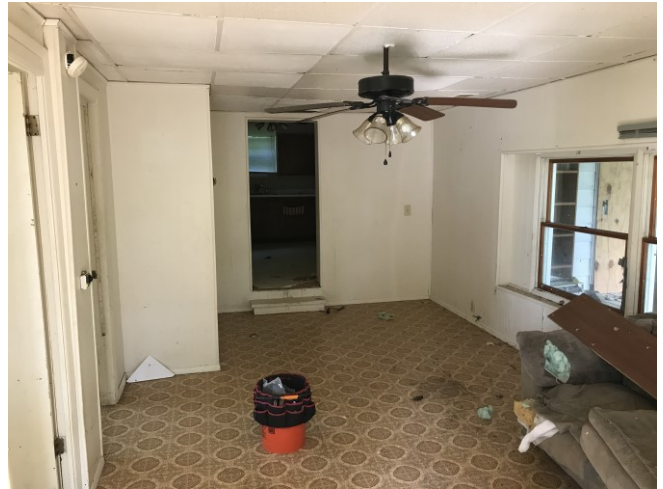
Location of Samples 227-5-1 (ceiling tile), 227-6-1 (linoleum) and 227-12-1 (fiberboard ceiling panel)

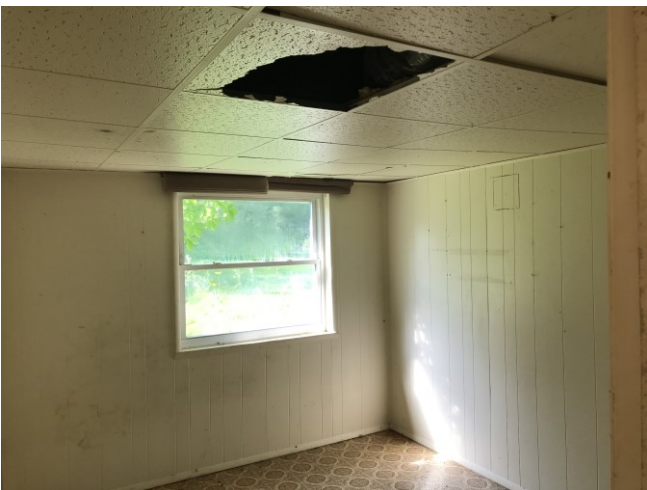
Location of Samples 227-5-2 (ceiling tile), 227-6-2 (linoleum) and 227-12-2 (fiberboard ceiling panel)

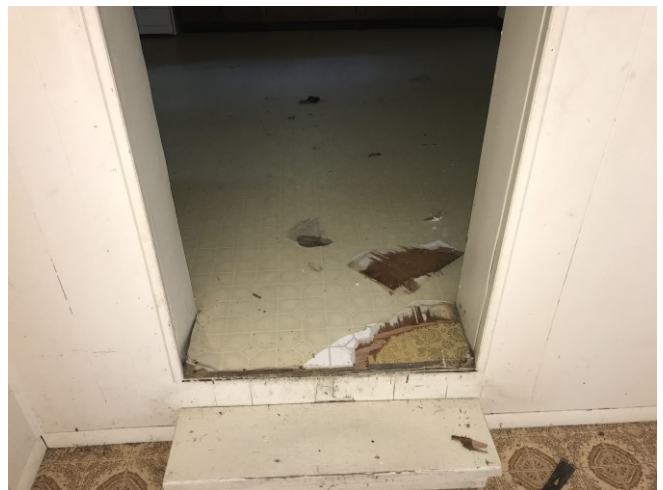
- Approximately 240 square feet of asbestos-containing linoleum is located in the kitchen (Area 4 on drawing). The ACM is located under a non-asbestos containing linoleum and ¼” wood subfloor material. The ACM is in a friable (fair) condition.

Location of Samples 227-8-1/2 (linoleum) and 227-9-1/2 (linoleum under top layer and subfloor)

227-8-2 / 21025456-016 Linoleum / Area 4	White Fibrous Homogeneous	35% Cellulose 5% Glass	60% Other	None Detected
227-9-1 / 21025456-017 Linoleum / Area 4	Tan Non-Fibrous Heterogeneous	10% Cellulose	70% Other	20% Chrysotile
227-9-2 / 21025456-018 Linoleum / Area 4	Tan Non-Fibrous Heterogeneous	10% Cellulose	70% Other	20% Chrysotile

The asbestos-containing linoleum in Area 4 is a regulated asbestos-containing material (RACM) in accordance with Kentucky EPA regulations. Kentucky-licensed asbestos personnel should remove these materials prior to demolition in accordance with applicable asbestos regulations. A ten (10) day prior notification must be submitted to the local EPA office before starting the remediation efforts.

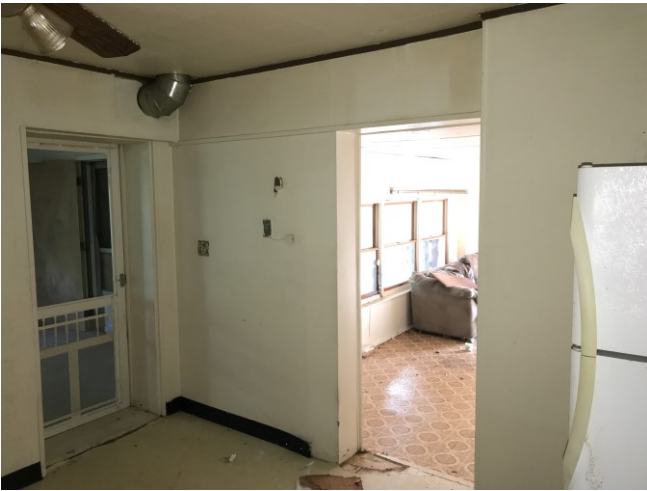
Location of Samples 227-7-1 (ceiling tile), 227-10-1 (drywall) and 227-11-1 (cove base)

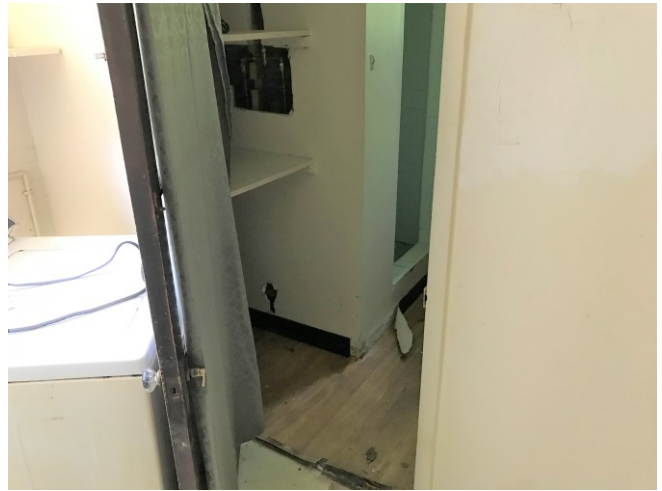
Location of Samples 227-7-2 (ceiling tile), 227-10-2 (drywall), 227-11-2 (cove base) and 227-13-1/2 (linoleum)

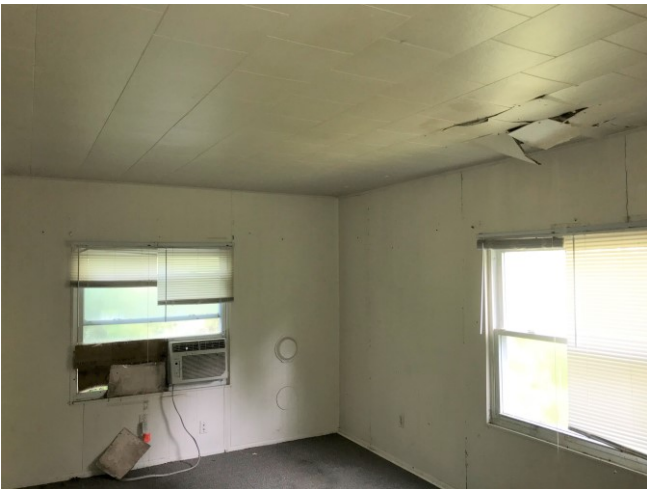
Location of Samples 227-14-1/2 (ceiling tile)

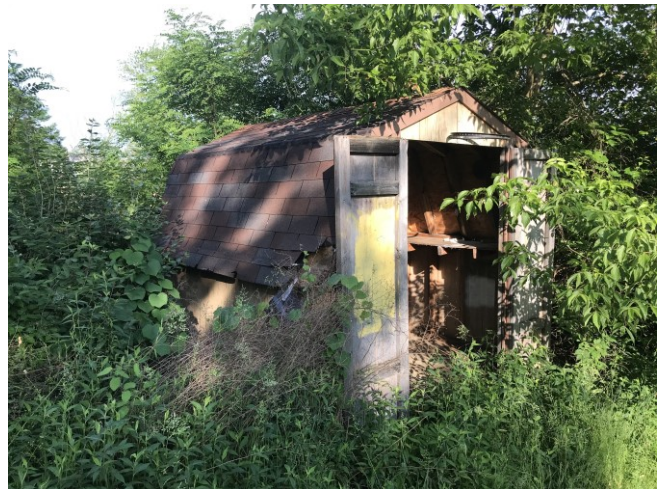
Location of Samples 227-17-1/2 (shingles – no felt present)
